PROGRAM FOR ESTABLISHING LONG-TIME FLIGHT SERVICE PERFORMANCE
OF COMPOSITE MATERIALS IN THE
CENTER WING STRUCTURE OF C-130 AIRCRAFT

PHASE III - FABRICATION

September 1974

Prepared under Contract No. NAS 1-11100 by
LOCKHEED-GEORGIA COMPANY
Marietta, Georgia

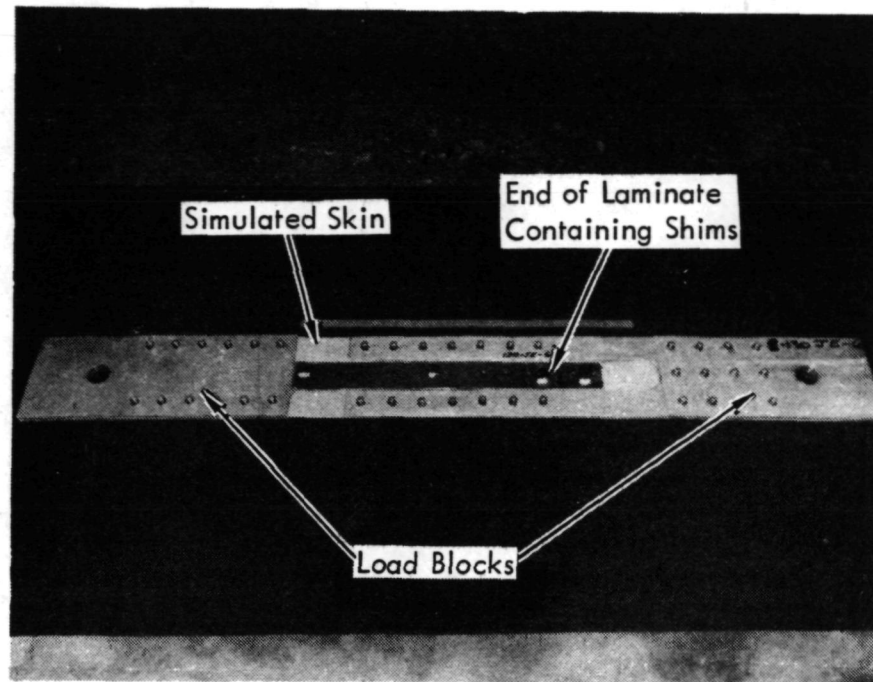
FIGURE 59: - 130-JE-6 DESIGN

The JE-6 test component illustrated in Figures 59 and 60 simulated the skin laminate run-out configuration for stringer #18 on the lower surface at the W.S. 140 cut-out. This component was successfully tested to a tension load which exceeded airplane ultimate load requirements by approximately 42%. Failure occurred by net section fracture of the boron-epoxy laminate at a fourth fastener location near the laminate end. Strain data showed (Figure 61) that measured strains in the proximity of the failure were equal to, or exceeded, the boron-epoxy design ultimate tensile strength of 1.24 GN/m^2 (180 KSI).

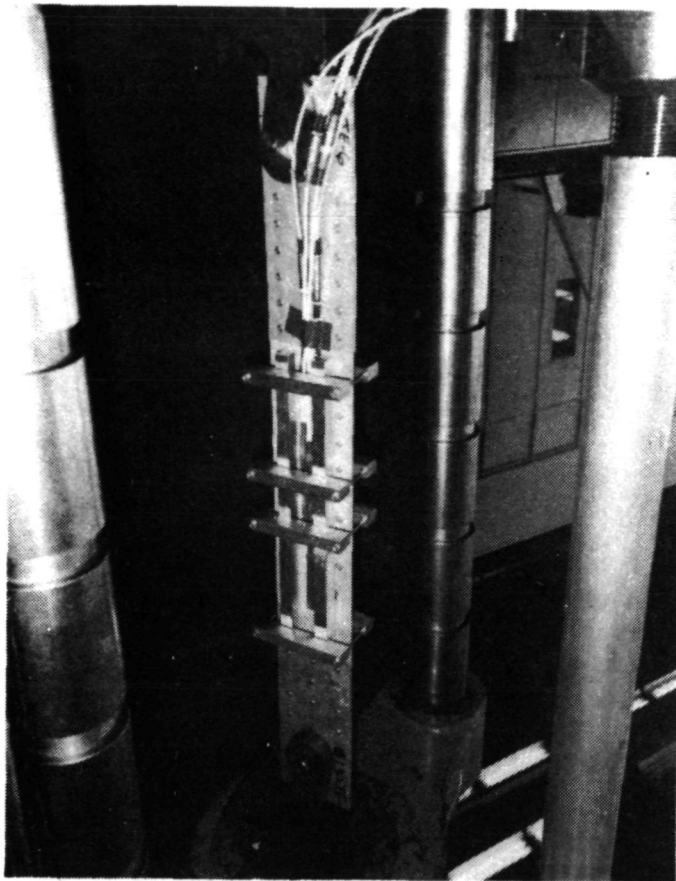
FIGURE 61. - 130-JE-6 STRAIN DATA

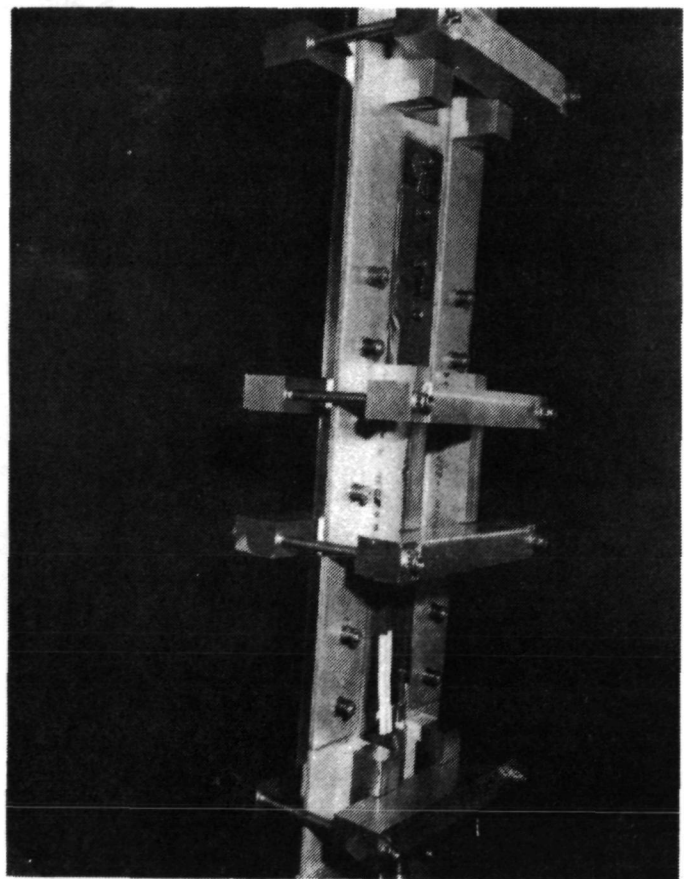
FIGURE 62. - SUPPORT FIXTURE
ARRANGEMENT ON
SKIN SIDE OF SPECIMEN

Prior to testing, each specimen was instrumented with eight electrical resistance type strain gages, and each specimen was fitted with a lateral support fixture. Eight axial strain gages were applied to each specimen. The support fixture was clamped to the specimens as illustrated in Figures 62 and 63. Teflon was used between the specimen and spanwise support bars to minimize friction. Since the specimens were slightly bowed, straightening by the support arrangement prior to test provided a better representation of a skin-stringer combination.

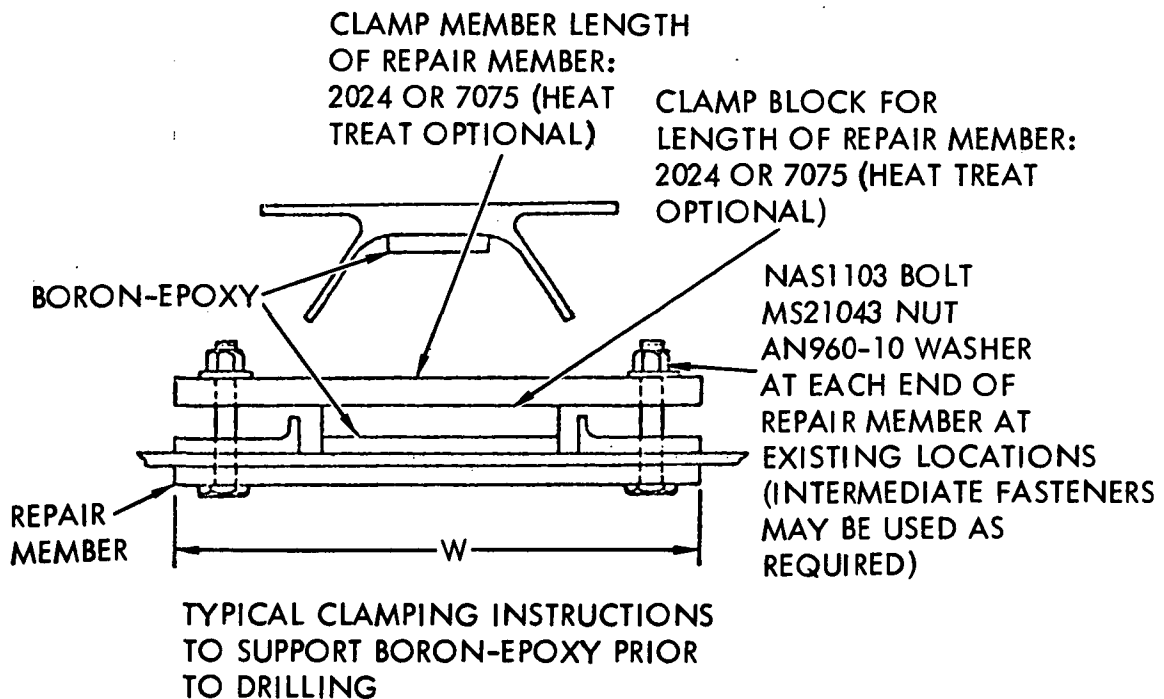
In order to keep repairs as simple as possible, all repairs utilized standard metal repair techniques. No attempt was made to incorporate advanced composite technology into the field repairs. Certain precautions were noted to preclude the possibility of damaging the boron-epoxy laminate or its bond to the metal while making the repairs. Clamping techniques, illustrated in Figure 71, and drilling instructions were included for areas requiring that holes be drilled through the boron-epoxy. A typical skin-laminate-bond repair, extracted from SMP881, is illustrated in Figure 72. Stringer repairs used a similar procedure.

1. BEFORE INSTALLING REPAIR DOUBLER (1) FILL ALL COUNTERSUNK HOLES IN SKIN WITH EPOXY RESIN EML-9-9000. INSTALL REPAIR DOUBLER (1) WITH FLAT SIDE AGAINST THE SKIN.
